# Report for Experiment

Experiment report for active water generator A

Experiment report for active water generator B

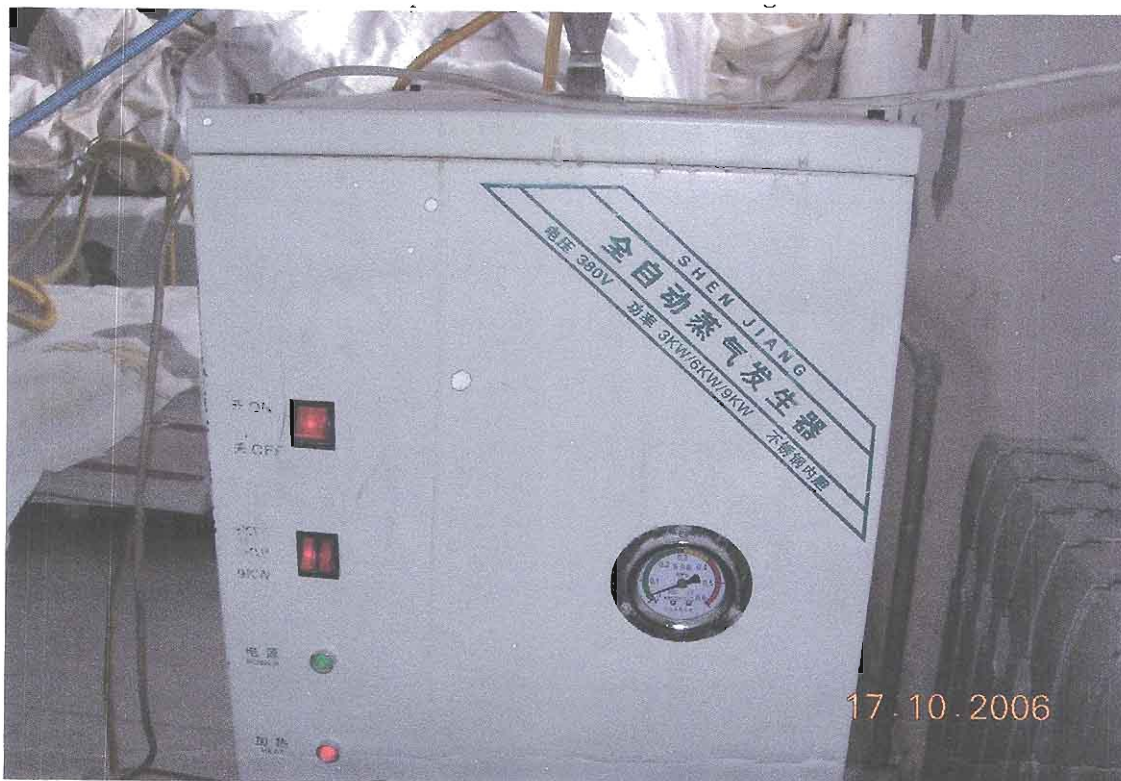
photo 1: steam generator for ironing

The test is made on Oct 16th of 2006, we made the test with a D15mm active water generator .Fix it At the front of the steam generator for the press in product line of knitwear. Please check the photo 1 for the steam generator.

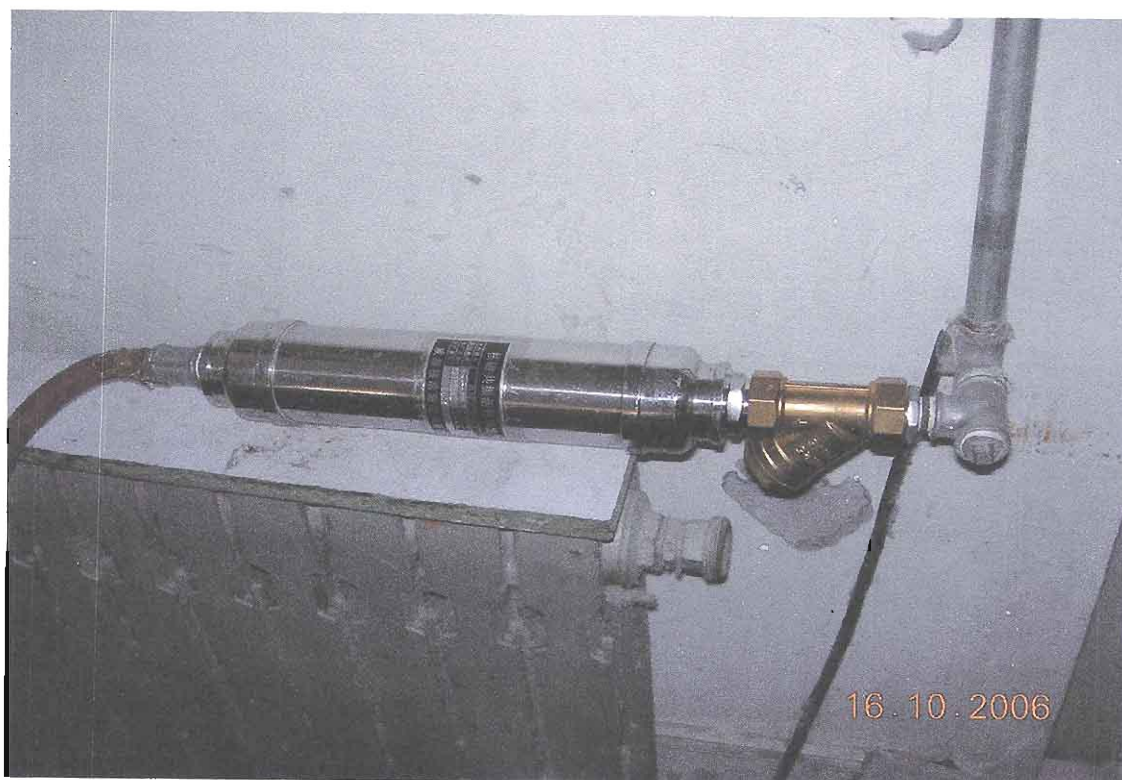
photo 2: field installation for active water generator

Fix the "active water generator" crosswisely on the flow pipe, as photo 2. in the way out, it jointed with steam generator by the hose. There is three hose on steam generator, which could supply the steam for three electric irons. The steam generator is heated by power. Please check the photo 3 and photo 4. one unit is including 3 heating pipe of 1kw, another unit including 3 heating pipe of 2kw. The max heating power is 9KW.

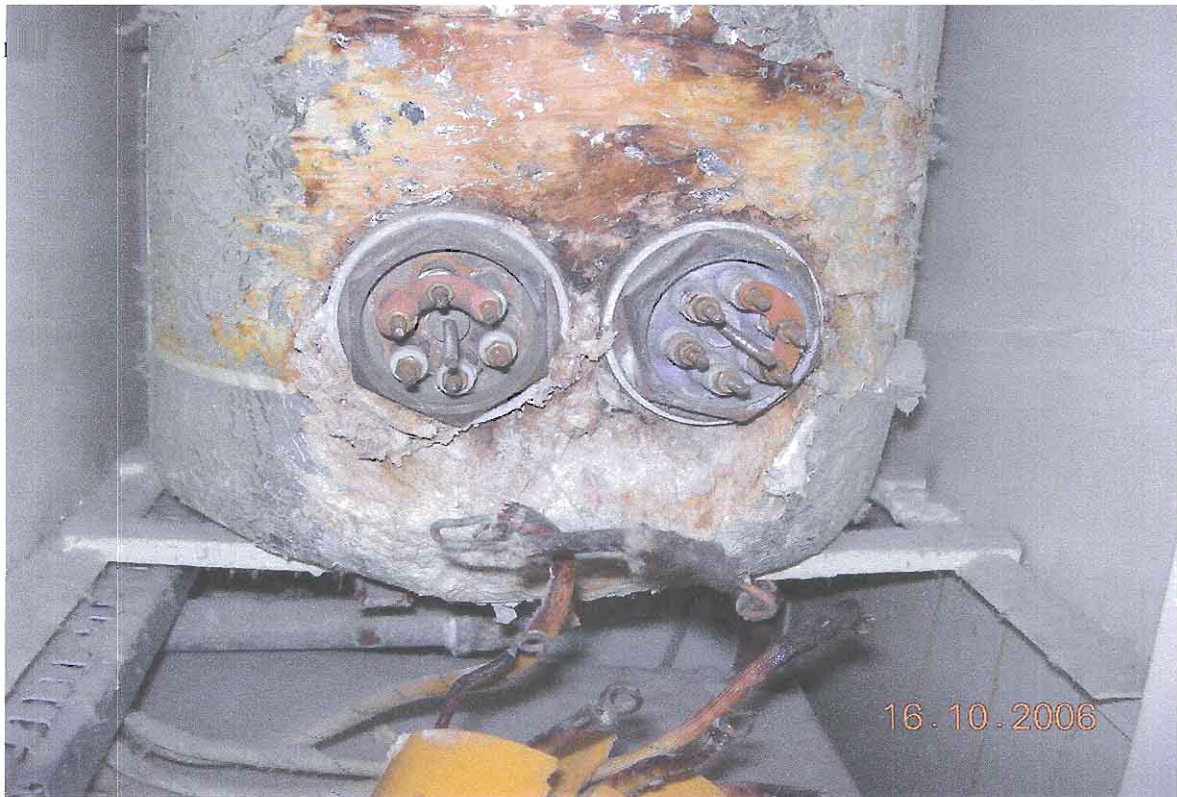
photo 3: the positon of the heating pipe.

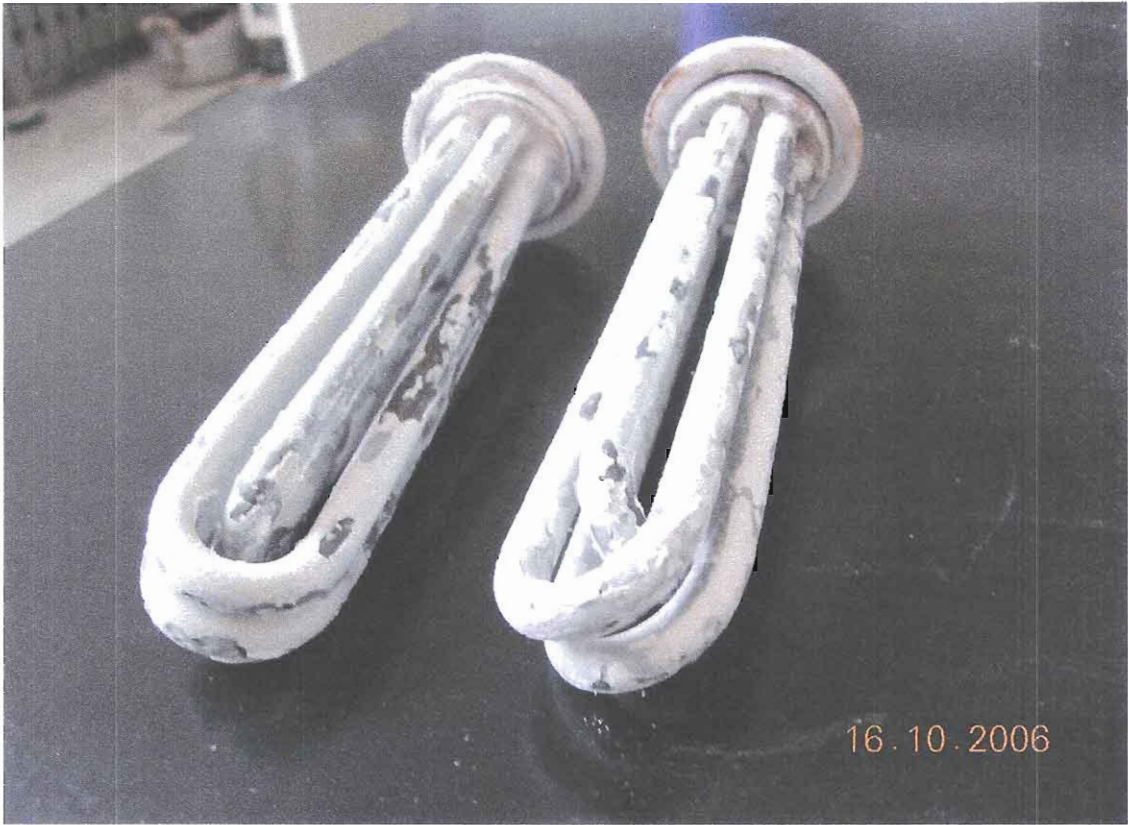
photo 4: electric heating pipe

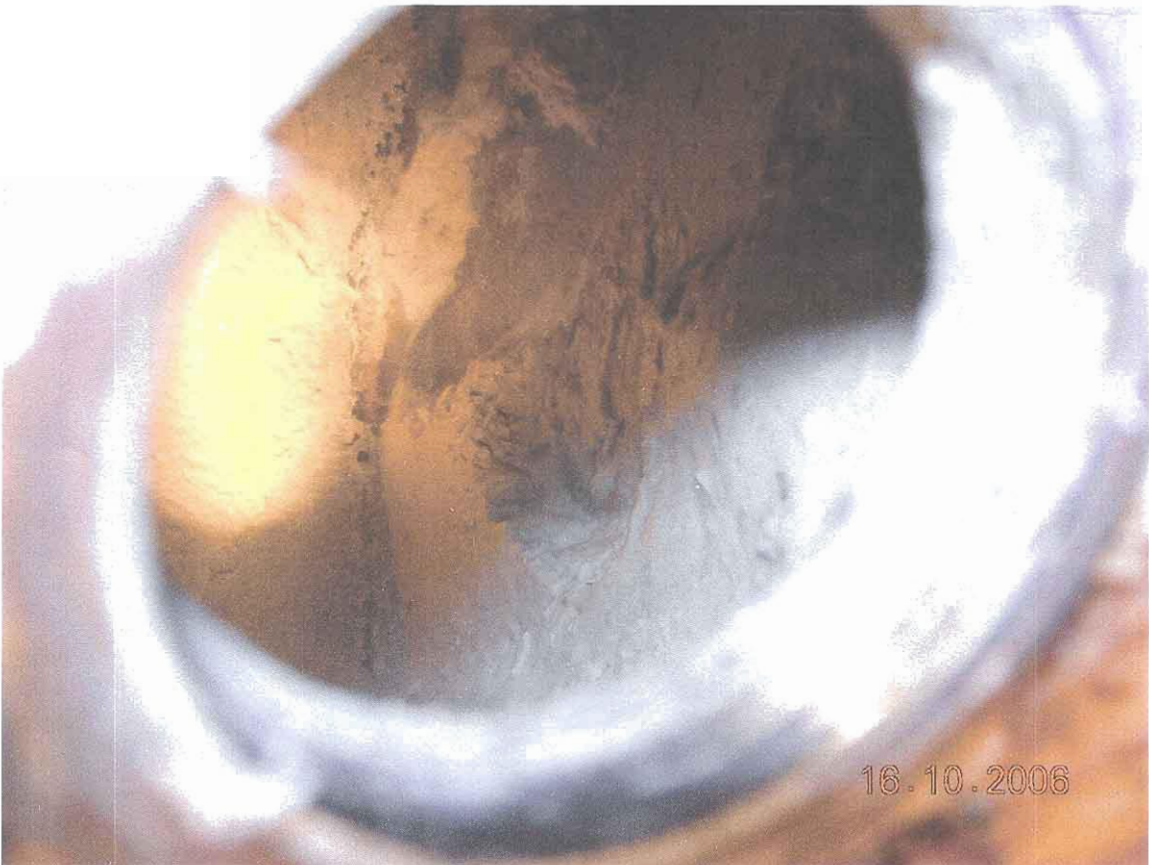
The steam drum of the steam generator is D270x440mm(about 25L). as all the product of knitwear required ironing before delivevr. the steam generator work continuously over 18 hours per day. During this test, we could check the internal of the steam drum from the mounting hole of the electric heater, please check the photo 5. the scale is about 5mm thick inside of the steam drum, it is hard. The factory have clear the scale 2 month ago, before the cleaning, the stem drum has worked for over 6 months which caused the scale is all over the heater. When we do this test, We did not clean up all the scale inside the hearter which has been there for over 6 months. we just want to check the effect of descaling.

photo 5: the internal status of the steam drum before  
“active water generator” fixed

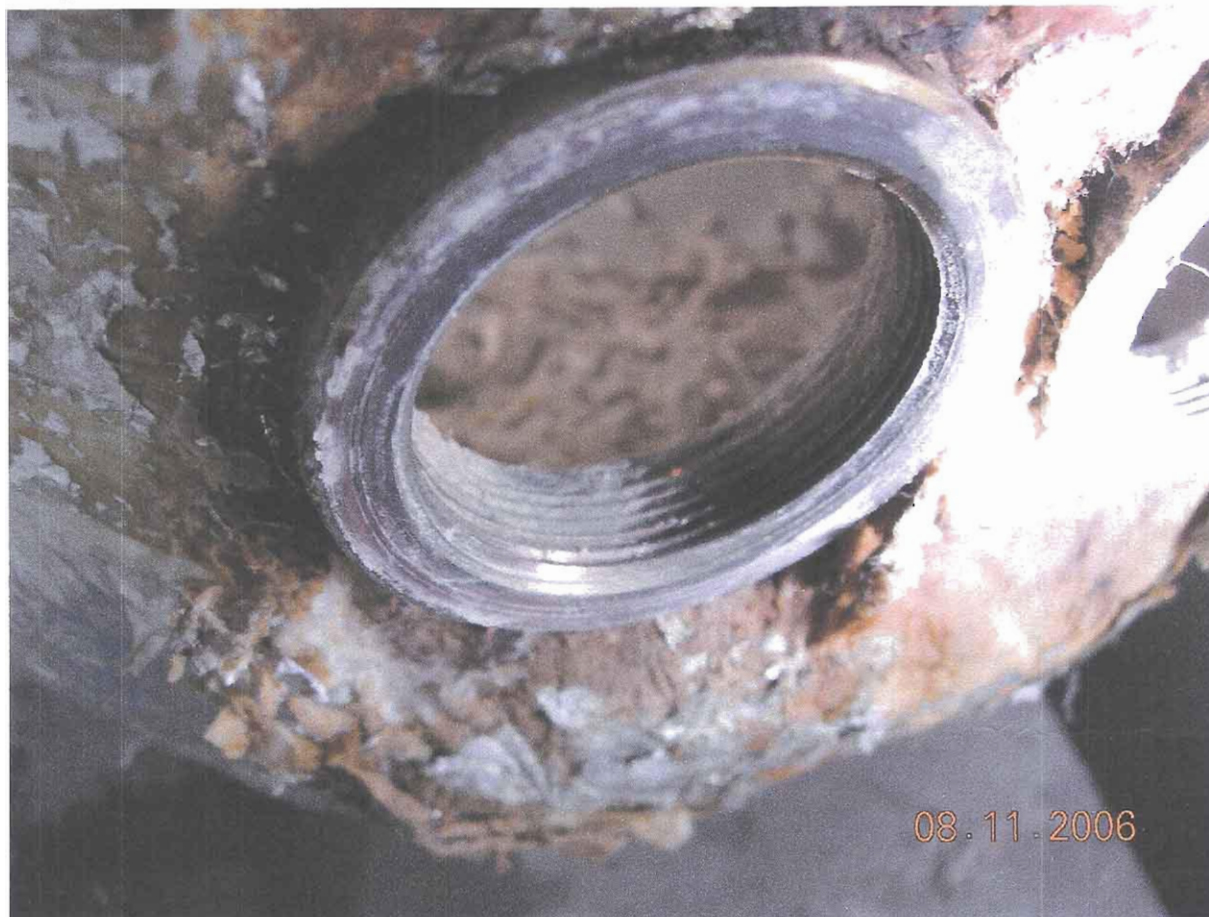
On Nov 8th of 2006, the knitwear factory overhaul the heating pipe of the steam generator. It means about 22 days after they use the "active water generator" at this time. After remove the heating pipe, we could check the internal status of steam drum: the scale in the sidewall become more thin obviously, there is old scale at the bottom of the steam drum which broke off from the sidewall, please check the photo 1.

photo 1: The bottom of the steam drum

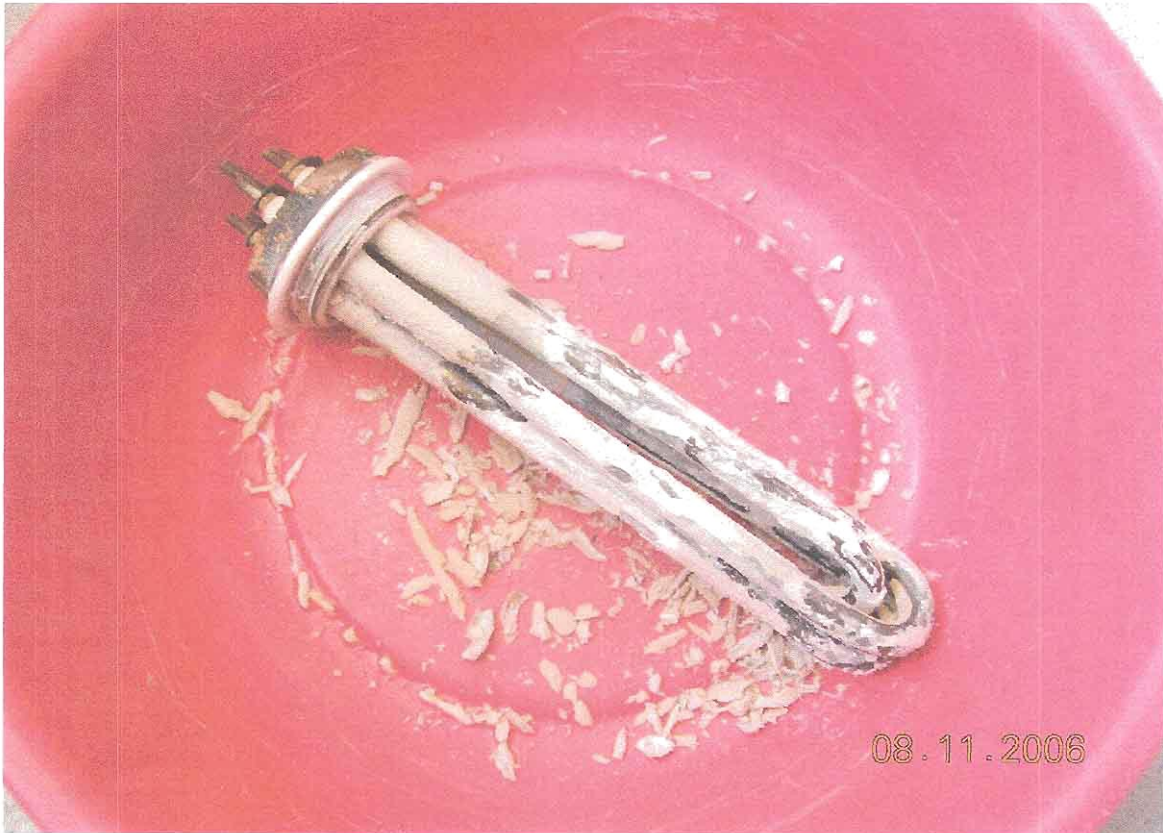
After the 22 days of the running of "active water generator", the scale on the heating pipe become easy to be peeling off. Please check photo 2, which is the hearing pipe after cleaning. For the photo 3, it is the comparison of two heating pipe. The upper one is before clearing the scale, there is some new scale on it.

photo 2: the scale on the heating pipe become easy to be peeling off

Conclusion: Even the device just run 22 days, the effect of descaling and anti-scaling is much obviously
